# Inspection Report

St. Marks Ave.  
Brooklyn NY 11213

**Five Borough Home Inspection, LLC**

<b>Date:</b> 5/24/2013	<b>Time:</b> 2:00 PM	<b>Report ID:</b> 05242013B
<b>Property:</b> St. Marks Ave. Brooklyn NY 11213	<b>Customer:</b>	<b>Real Estate Professional:</b>

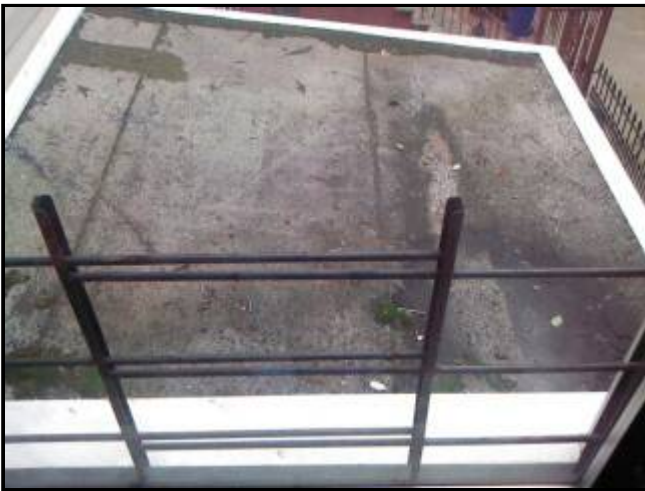
1.0 Picture 1 front roof

(1) This front porch roof needs to be replaced as seen from second floor window.

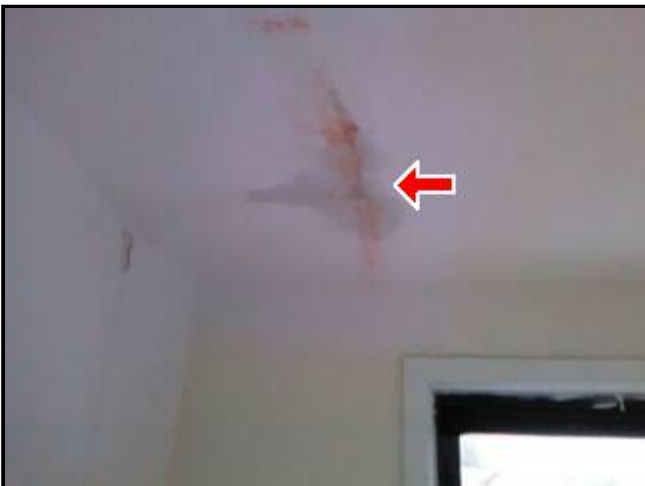
1.0 Picture 2 ceiling

(2) There is a roof leak into front room on the second floor.

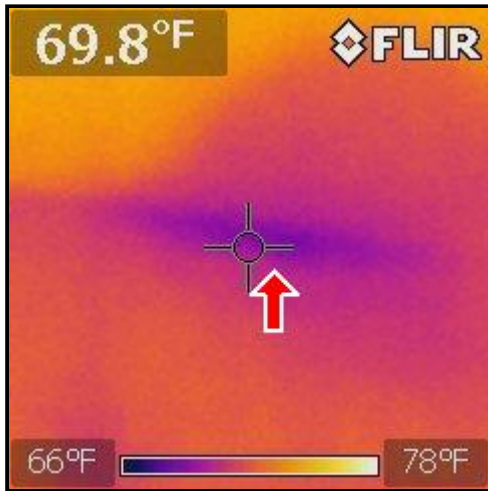
1.0 Picture 3

(3) There was no access to the main roof via the roof hatch. Although this roof was not directly inspected there is plenty of evidence to suggest that it is deficient and needs to be replaced. First there is the fact that the smaller visible roofs front and rear are either leaking or show visual disrepair. Second, the infra imaging shows moisture and water penetration on the ceiling and wall at the rear second floor behind the bathroom. This area is under the main roof. Without access to the main roof it must be assumed that it is deficient and needs replacement.

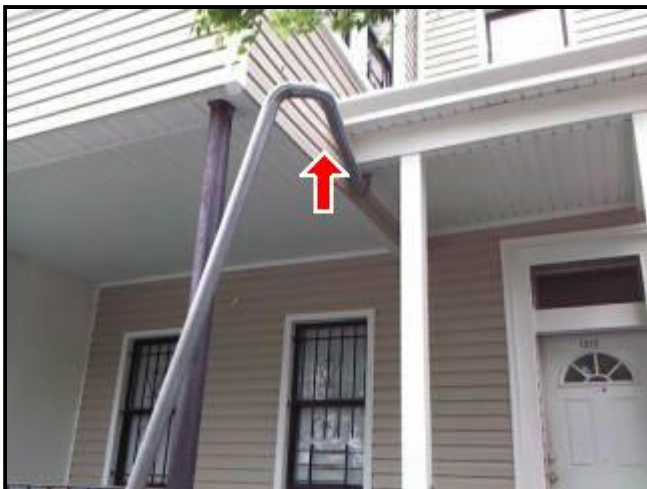
1.3 Picture 1 roof drain

The front roof drain has detached from the building. This roof drain has also incurred DOB violations since it pours onto the sidewalk and not into the sewer.

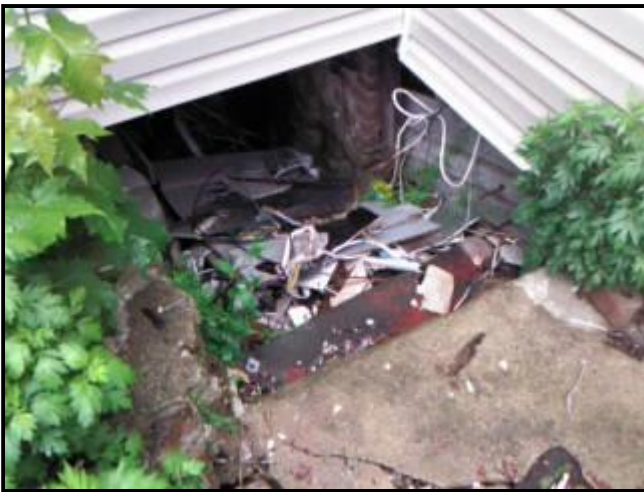
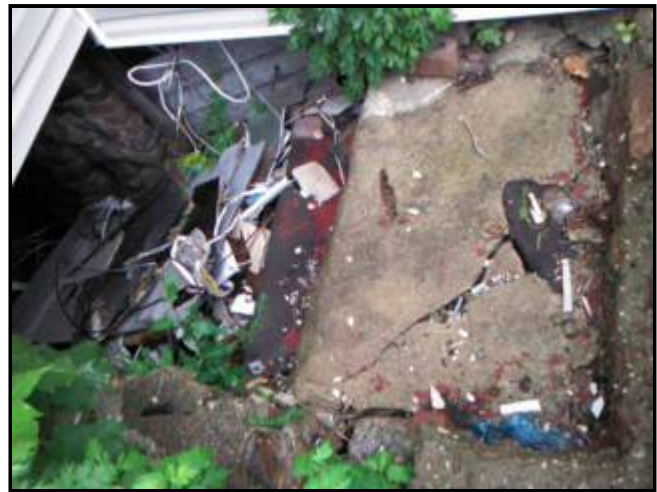
The cement and stairway at the rear of the building into the basement needs to be reconstructed.

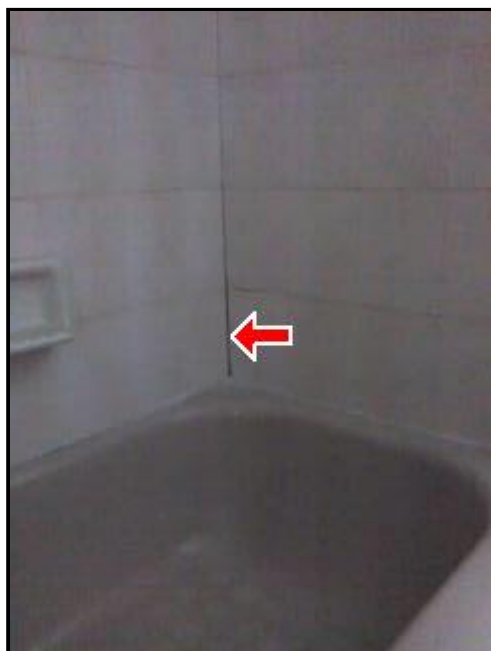
7.3 Picture 1 tub

- (1) The plumbing faucet leaks under the sink cabinet.
- (2) The bath tub cold water tap does not work.
- (3) The tub needs grout repair.

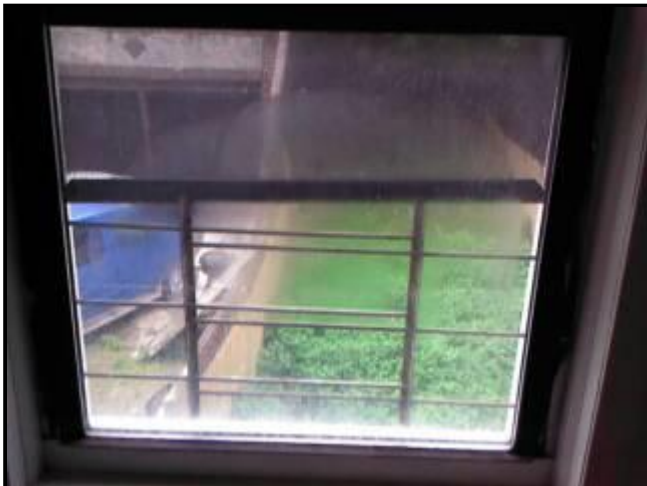
9.5 Picture 1 window

Most of the windows in this house have broken thermo seals which results in visible condensation between the glass panes. This also reduces the insulative value of the window. Window replacement is required.

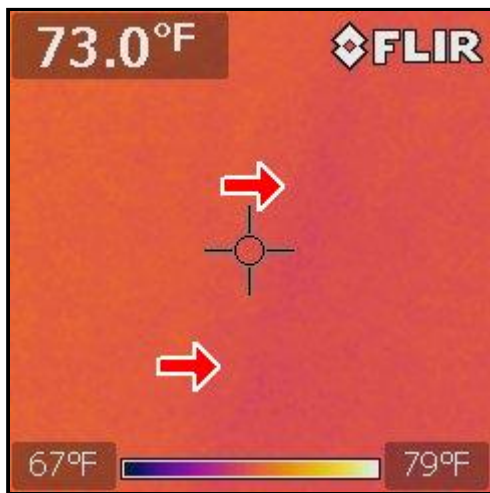
11.1 Picture 1 thermo image

In the hall closet there is evidence of black mold and the thermo imaging shows water penetration.

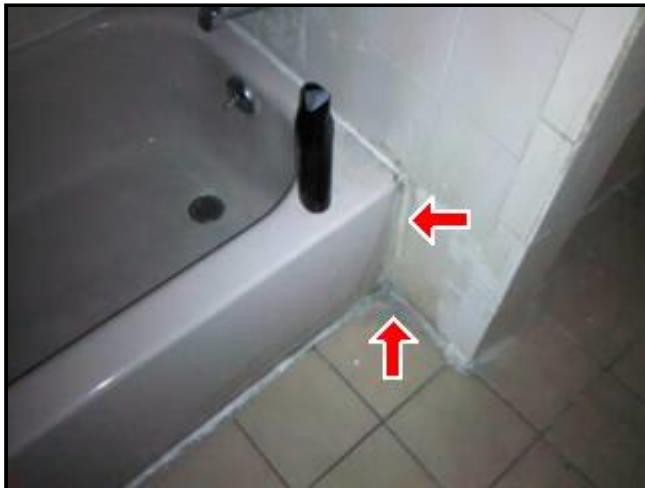
12.3 Picture 1 tub

(2) The tub needs grout and tile repair.

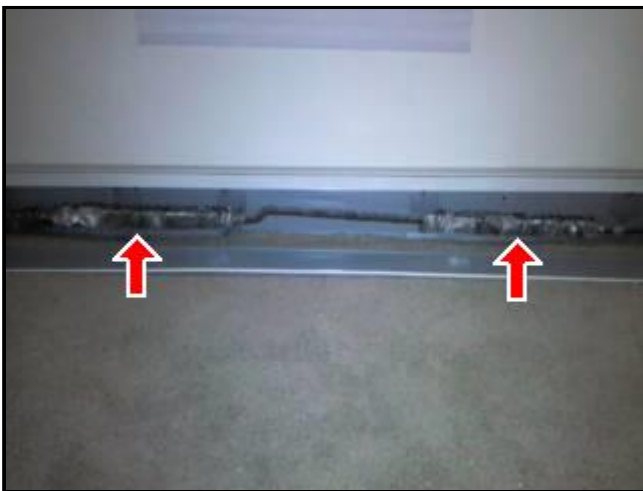
15.3 Picture 1 radiator

All baseboard radiators need replacement in this building. The heat conducting fins are damaged and in poor condition.

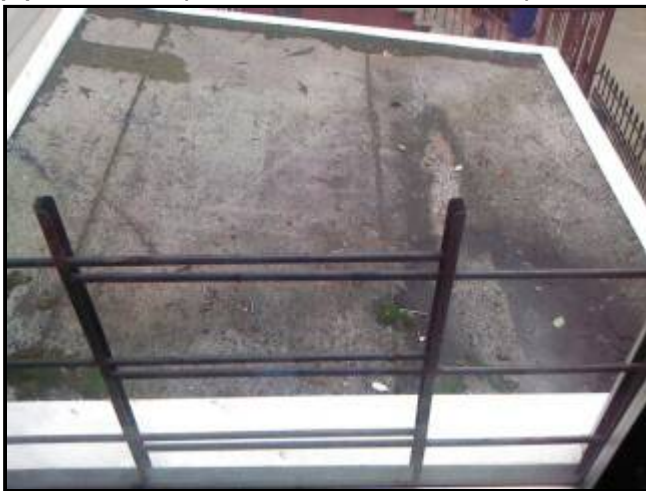
1.0 Picture 1 front roof

(1) This front porch roof needs to be replaced as seen from second floor window.

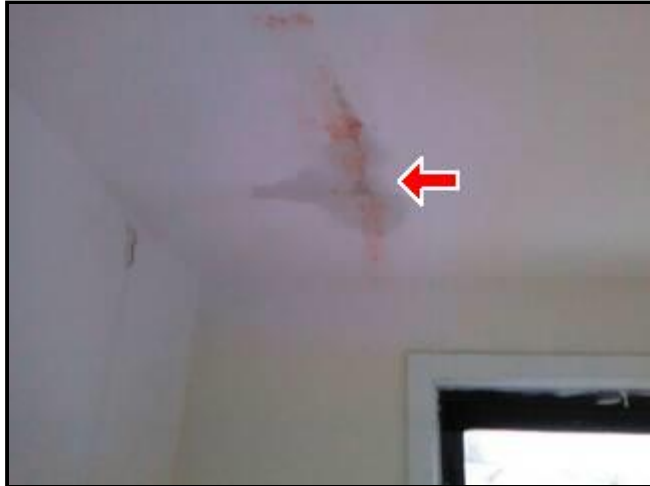
1.0 Picture 2 ceiling

(2) There is a roof leak into front room on the second floor.

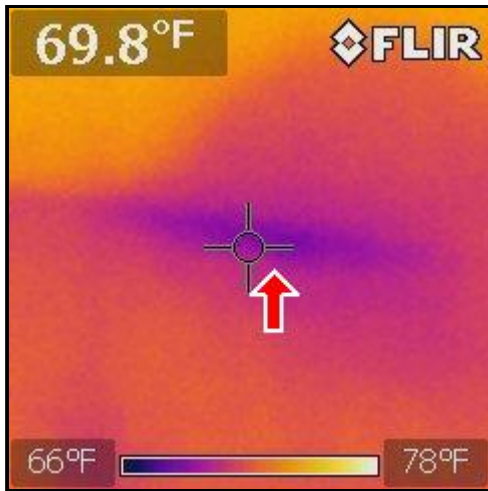
1.0 Picture 3

(3) There was no access to the main roof via the roof hatch. Although this roof was not directly inspected there is plenty of evidence to suggest that it is deficient and needs to be replaced. First there is the fact that the smaller visible roofs front and rear are either leaking or show visual disrepair. Second, the infra imaging shows moisture and water penetration on the ceiling and wall at the rear second floor behind the bathroom. This area is under the main roof. Without access to the main roof it must be assumed that it is deficient and needs replacement.

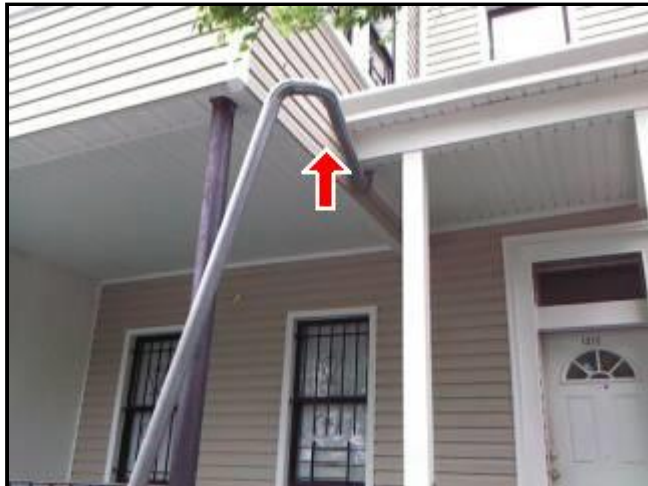
1.3 Picture 1 roof drain

The front roof drain has detached from the building. This roof drain has also incurred DOB violations since it pours onto the sidewalk and not into the sewer.

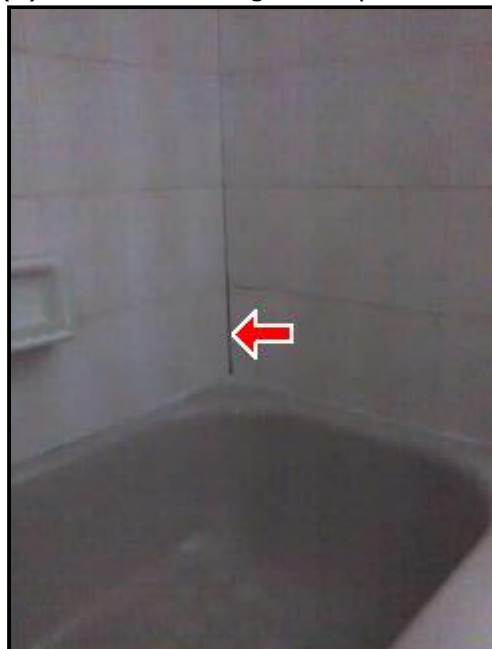
7.3 Picture 1 tub

- (1) The plumbing faucet leaks under the sink cabinet.
- (2) The bath tub cold water tap does not work.
- (3) The tub needs grout repair.

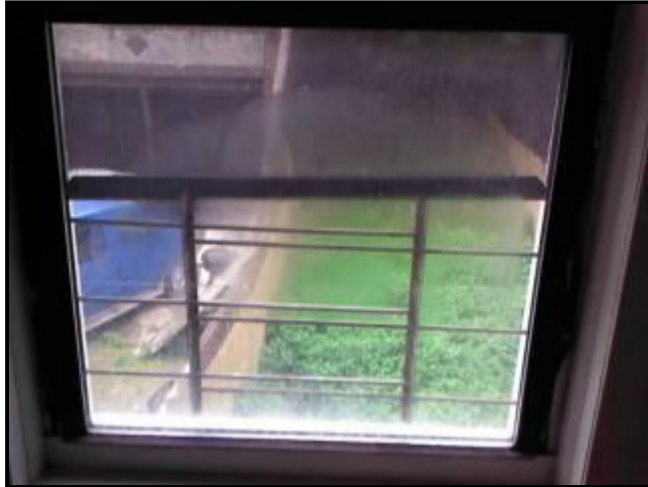
9.5 Picture 1 window

Most of the windows in this house have broken thermo seals which results in visible condensation between the glass pains. This also reduces the insulative value of the window. Window replacement is required.

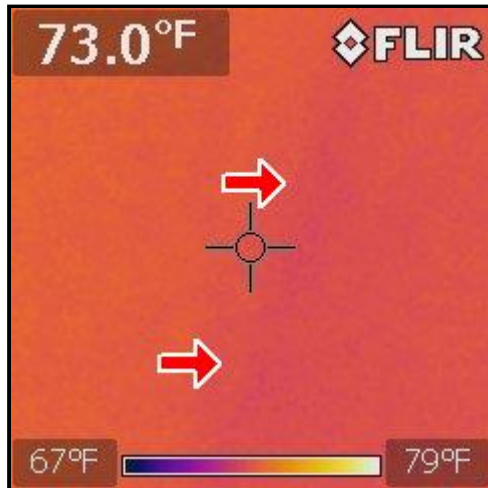
11.1 Picture 1 thermo image

In the hall closet there is evidence of black mold and the thermo imaging shows water penetration.

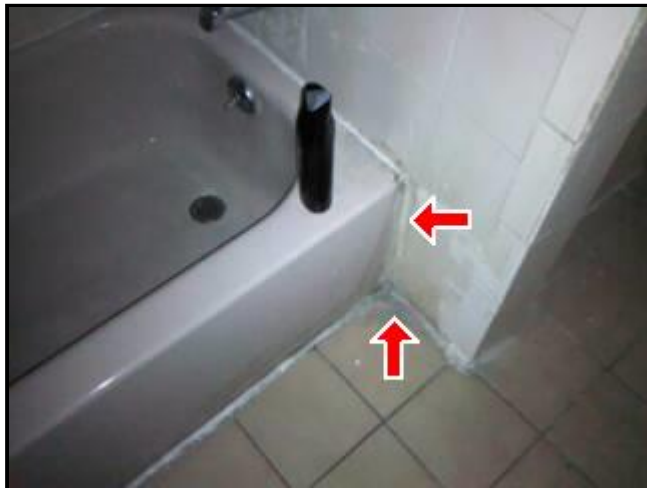
12.3 Picture 1 tub

- (1) The toilet is not connected.
- (2) The tub needs grout and tile repair.

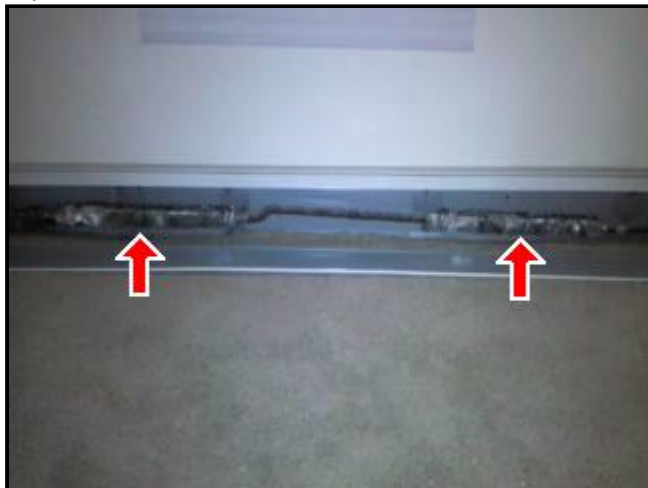
15.3 Picture 1 radiator

All baseboard radiators need replacement in this building. The heat conducting fins are damaged and in poor condition.
