Inspection Report

Kepler Ave.
Bronx NY 10470

Five Borough Home Inspection, LLC

Date: 2/26/2013	Time: 4:00 PM	Report ID: 2262013B
Property: Kepler Ave. Bronx NY 10470	Customer:	Real Estate Professional:

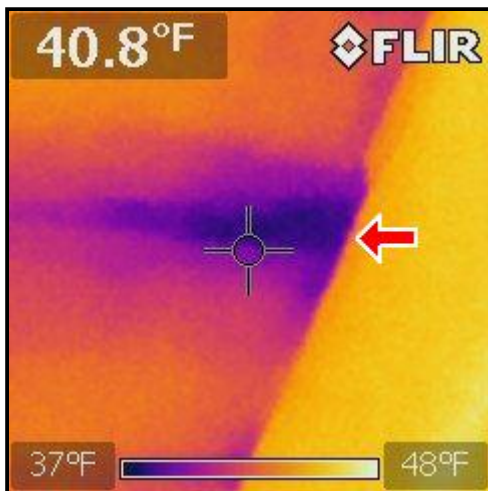
1.4 Picture 1

Leak area found on east side under third floor area by infrared. Moisture indicated at area in dark.

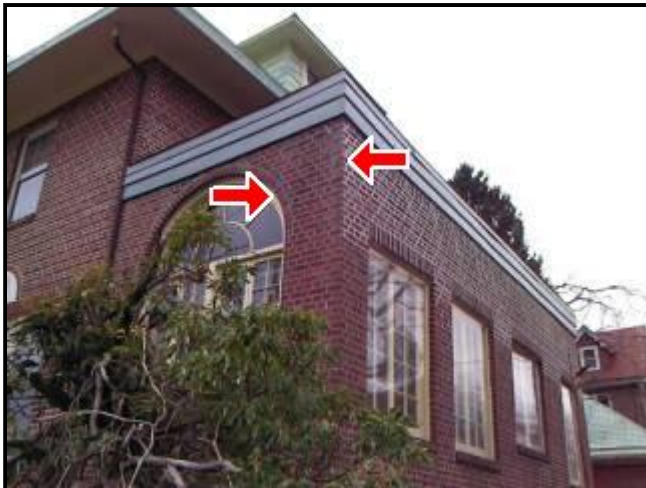
Pointing needed to repair brick.

2.0 Picture 1 brick needs pointing

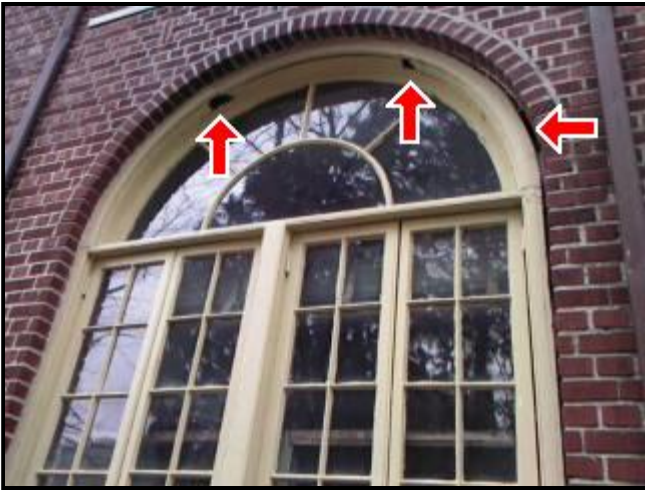
Condition around existing window frame requires repair.

2.2 Picture 1 rear first floor window

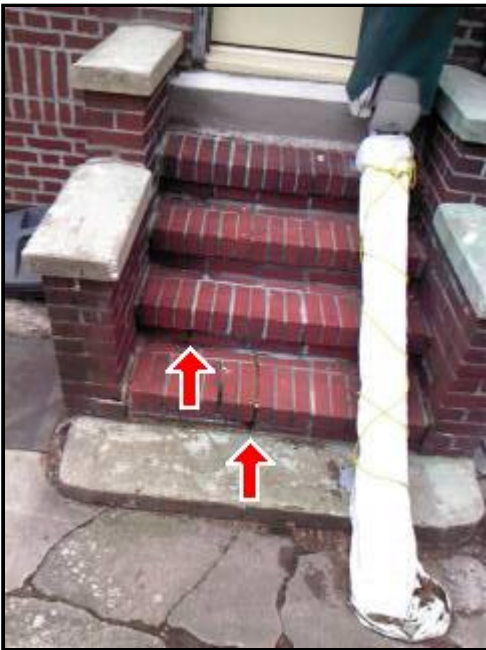
Rear steps need mortar repair.

2.3 Picture 1 rear steps

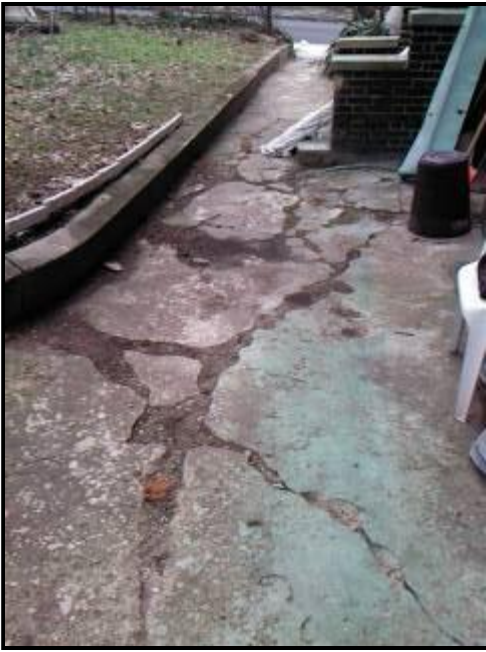
Concrete must be replaced on rear walkway.

2.4 Picture 1 rear walkway concrete

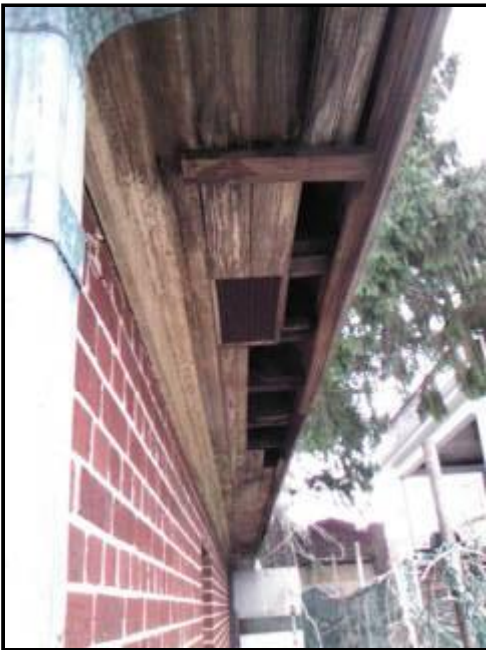
Replace side eave on garage.

2.6 Picture 1 garage eave

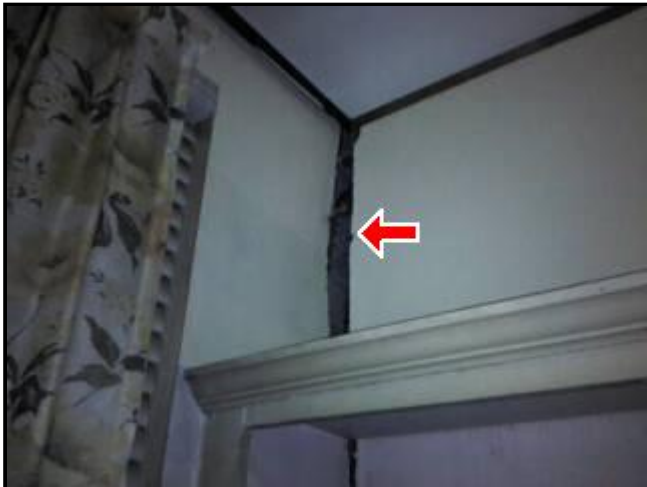
(1) Wall separation, first floor north side.

4.1 Picture 1 first floor north

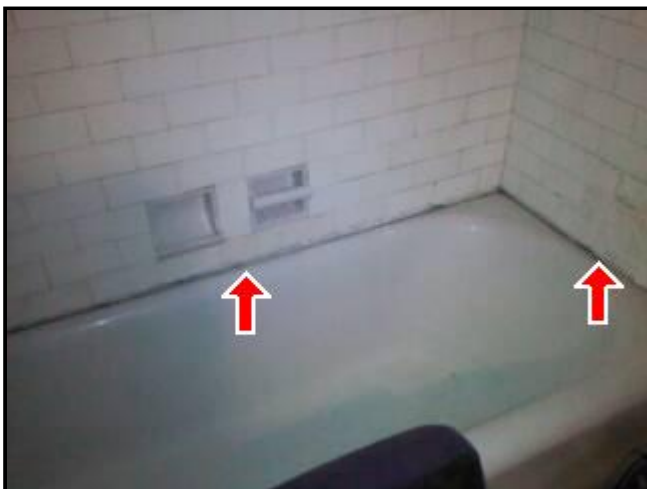
(2) Second floor bathroom tile repair.

4.1 Picture 2 second floor bath

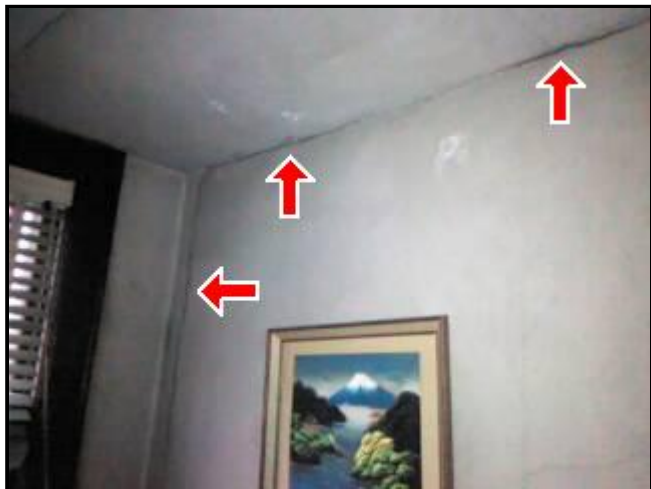
(3) Walls on third floor must replastered or new drywall applied. These walls have only rough plaster finish with many cracks.

4.1 Picture 3 third floor walls and ceiling

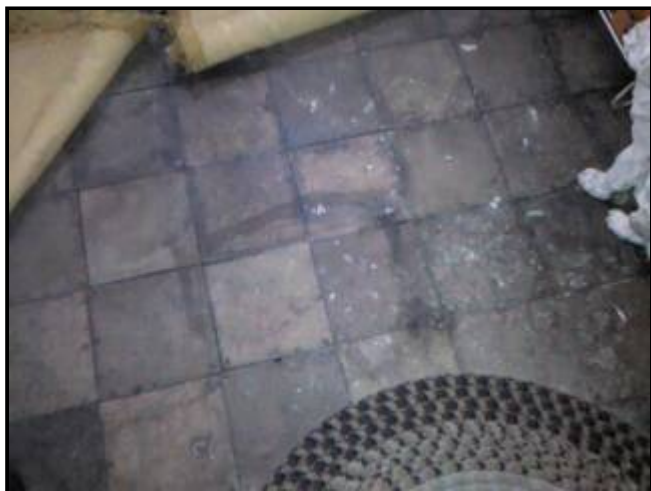
(1) Cork flooring in sun room needs to be replaced.

4.2 Picture 1 cork floor

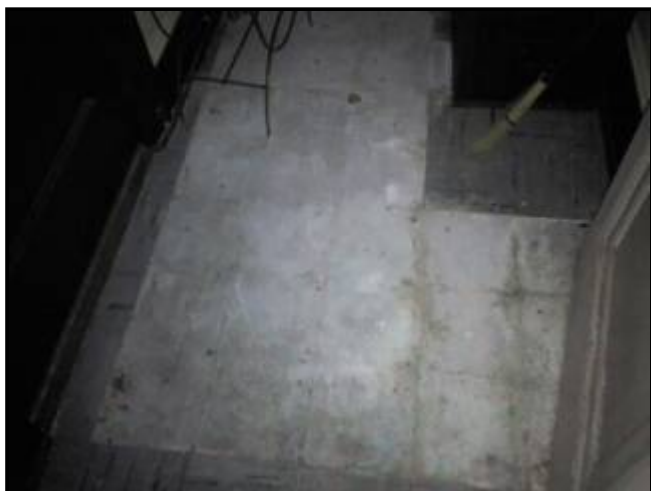
(2) floor in entrance behind kitchen needs to be replaced

4.2 Picture 2 floor behind kitchen

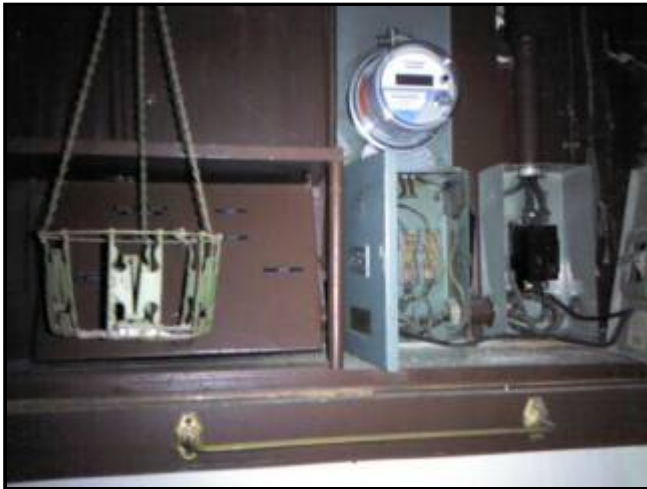
7.1 Picture 1

The electrical panels are a combination of old fuse boxes and new circuit breaker panels.

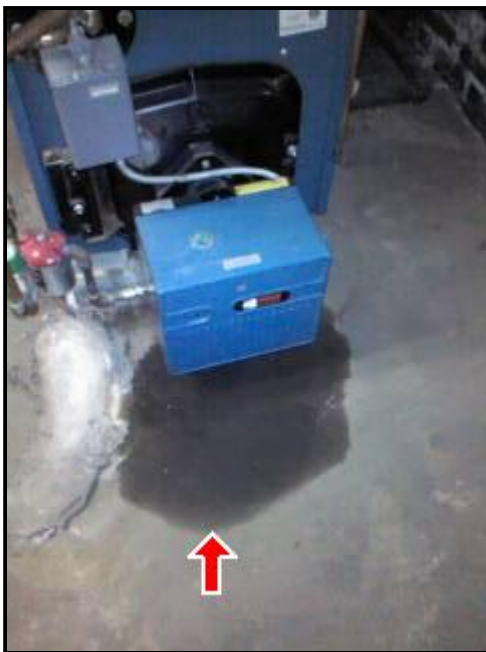
Small oil leak under burner.

8.0 Picture 1 oil leak

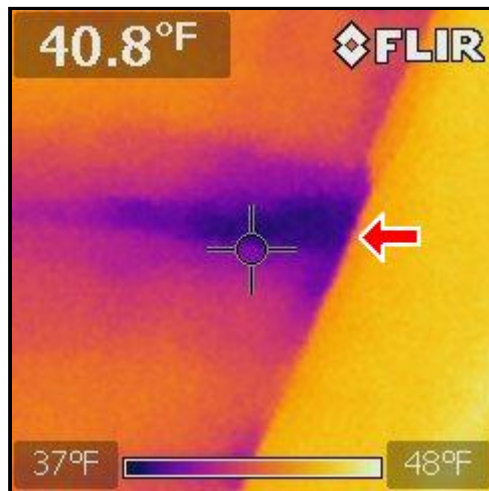
1.4 Picture 1

Leak area found on east side under third floor area by infrared. Moisture indicated at area in dark.

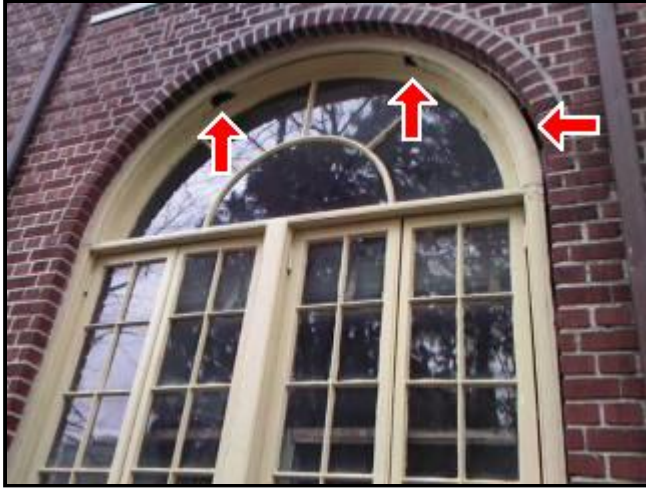
Condition around existing window frame requires repair.

2.2 Picture 1 rear first floor window

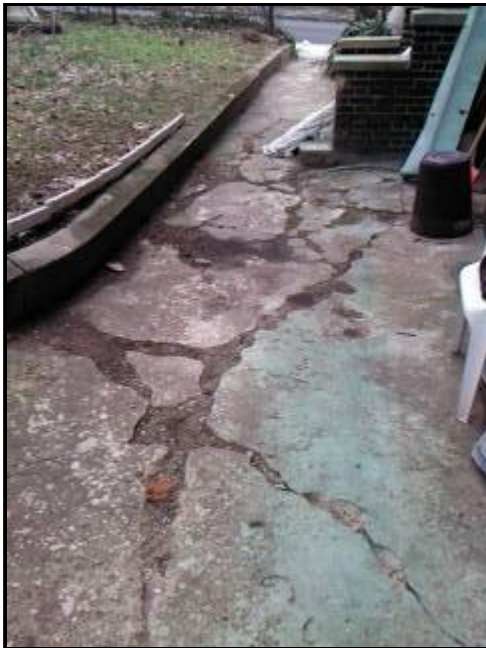
Concrete must be replaced on rear walkway.

2.4 Picture 1 rear walkway concrete

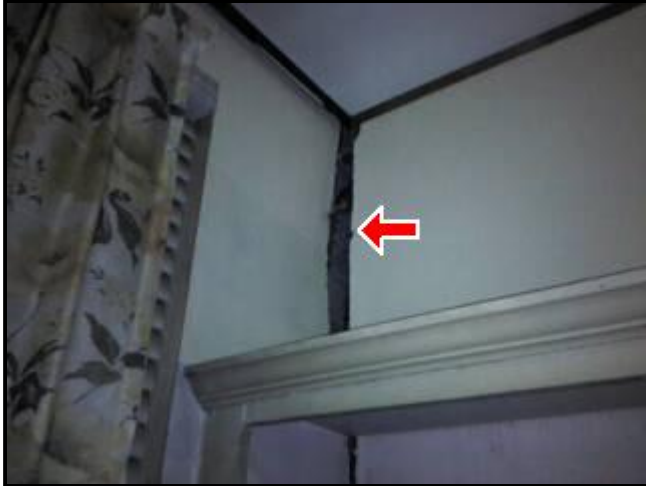
(1) Wall separation, first floor north side.

4.1 Picture 1 first floor north

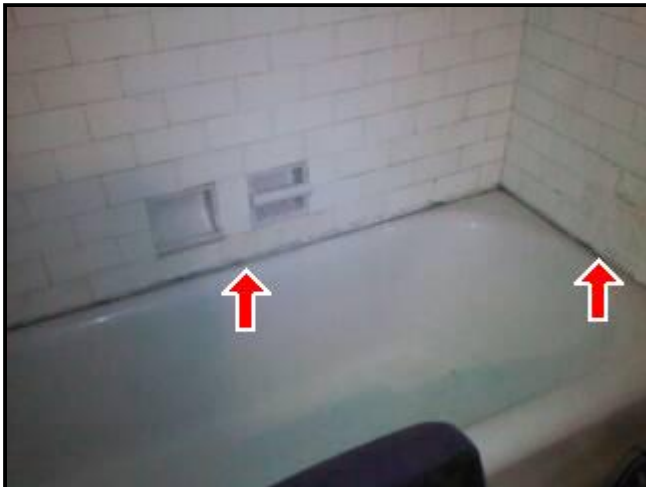
(2) Second floor bathroom tile repair.

4.1 Picture 2 second floor bath

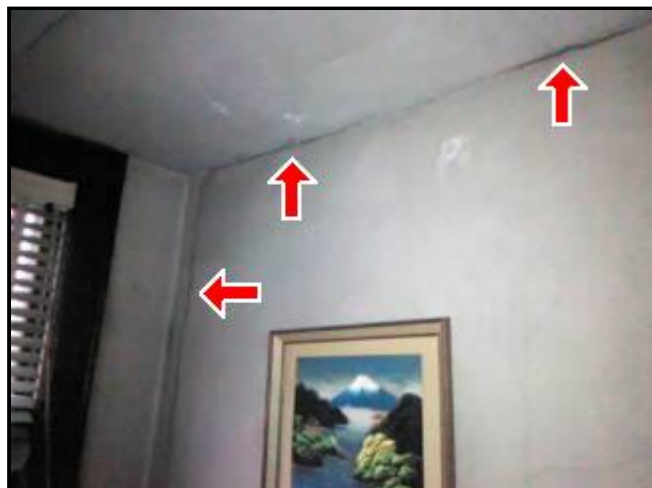
(3) Walls on third floor must replastered or new drywall applied. These walls have only rough plaster finish with many cracks.

4.1 Picture 3 third floor walls and ceiling

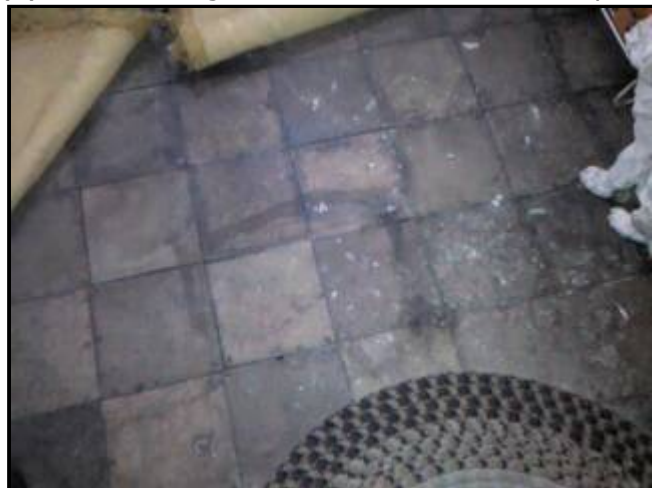
(1) Cork flooring in sun room needs to be replaced.

4.2 Picture 1 cork floor

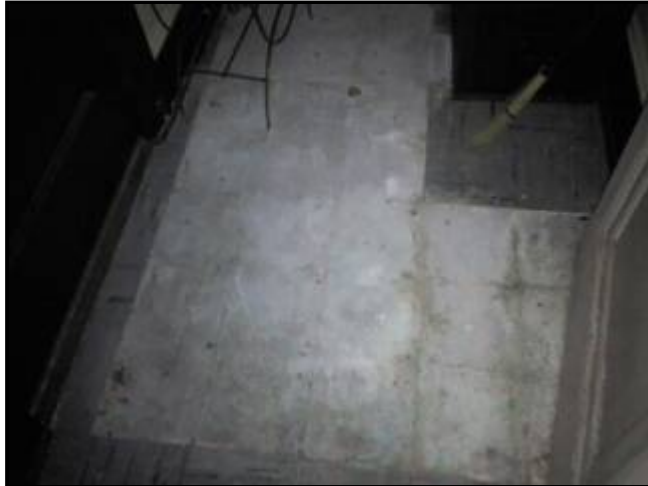
(2) floor in entrance behind kitchen needs to be replaced

4.2 Picture 2 floor behind kitchen
